## **Reflective Cracking Testing Notes**

**Date:** March 20, 2017

**Project:** Reflective Cracking Indoor Phase 5

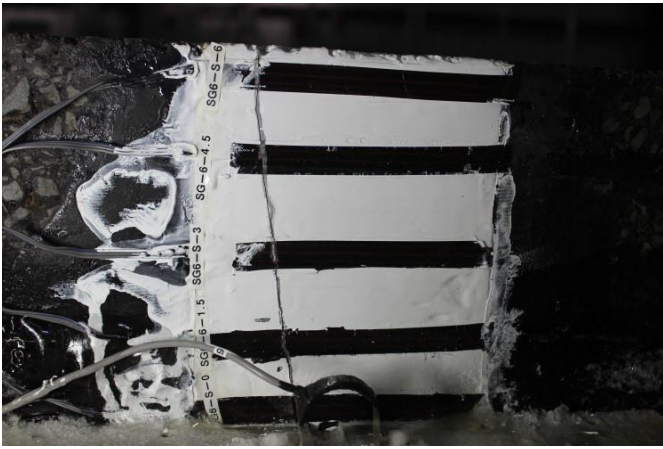
- Outer vertical edge:
  - Note: All pictures were taken in the 12 mil open condition.
  - No significant visual changes were observed.
  - The South outer vertical edge is cracked, as shown in Figure 1.
- Joint surface area:
  - No significant visual changes were observed.
  - First top surface gauge SG5-S-6, as shown in Figure 2.
  - Second top surface gauge SG4-S-6, as shown in Figure 3.
  - Third top surface gauge SG3-S-6, as shown in Figure 4.
  - Fourth top surface gauge SG2-S-6, as shown in Figure 5.
  - Top view of the South test section surface crack, as shown in Figure 7.
- Inner vertical edge:
  - No significant visual changes were observed.
  - The South inner vertical edge is cracked, as shown in Figure 6.

Figure 1. South outer vertical edge

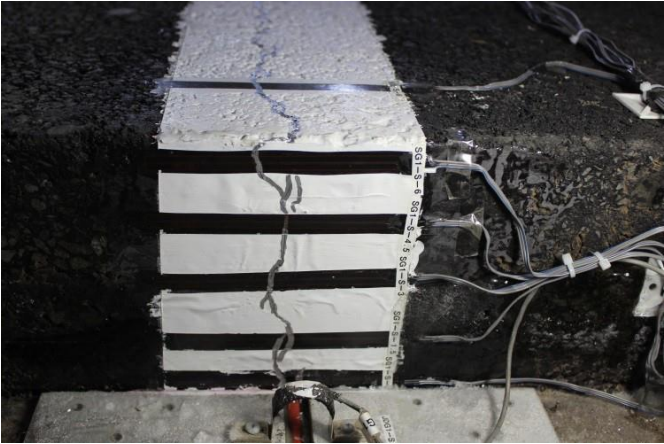
Figure 6. South inner vertical edge

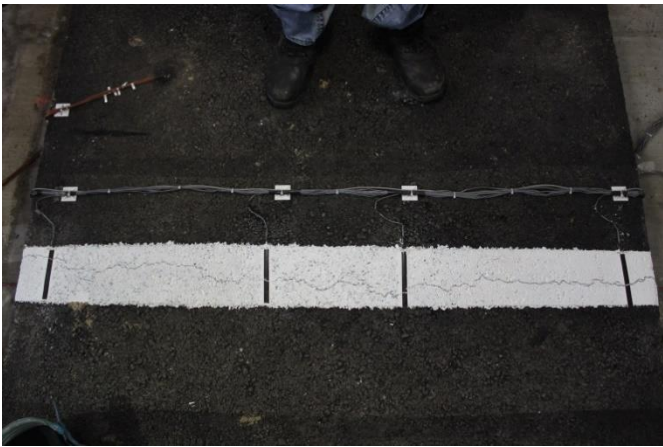
Figure 7. Top view of South test section surface crack

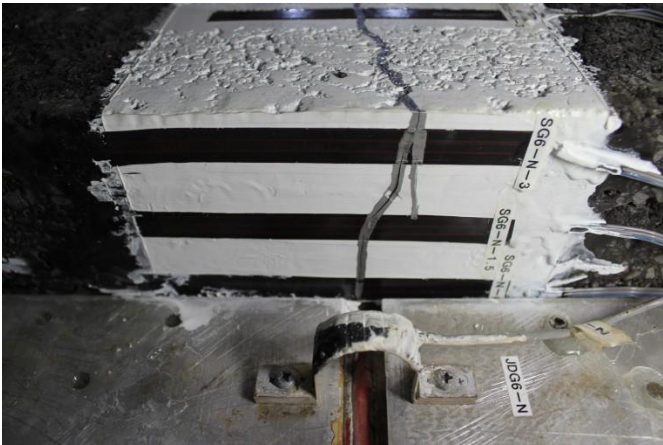
- Outer vertical edge:
  - Note: All pictures were taken in the 12 mil open condition.
  - No significant visual changes were observed.
  - The North outer vertical edge is cracked, as shown in Figure 9.
- Joint surface area:
  - No significant visual changes were observed.
  - First top surface gauge SG5-N-3, as shown in Figure 10.
  - Second top surface gauge SG4-N-3, as shown in Figure 11.
  - Third top surface gauge SG3-N-3, as shown in Figure 12.
  - Fourth top surface gauge SG2-N-3, as shown in Figure 13.
  - See inner coming crack propagation below SG2-N-3 and outer coming crack propagation at the right side of SG2-N-3, as shown in Figure 14.
- Inner vertical edge:
  - No significant visual changes were observed.
  - The North inner vertical edge is cracked as shown in Figure 15.

Figure 9. North outer vertical edge

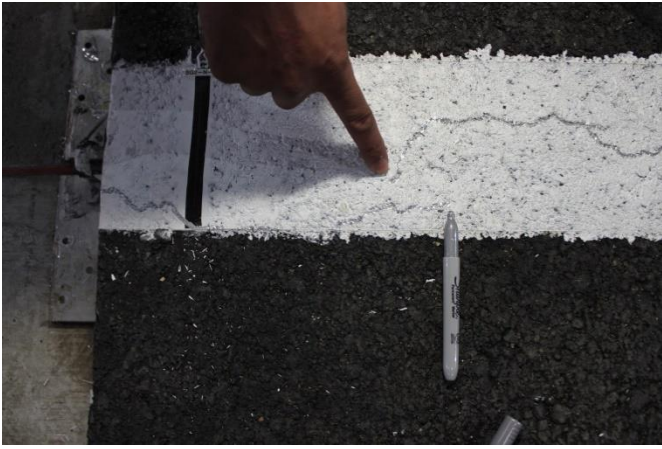
Figure 14. Place where the inner and outer cracks come together (to the right of SG2-N-3)

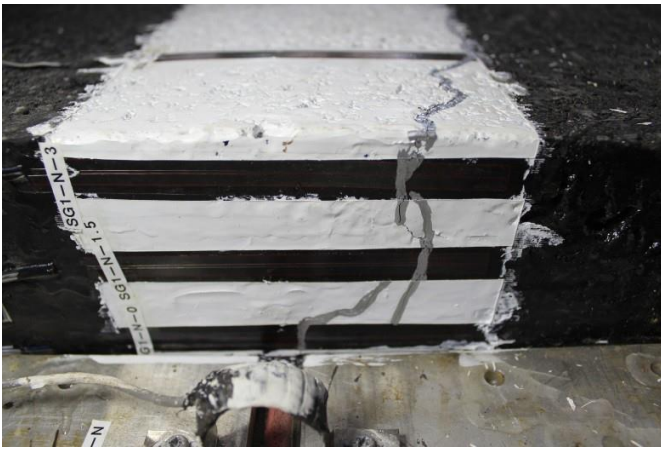
Figure 15. North inner vertical edge
